# PUNTO STABILE RESITUTION

# OF RISING OF THE HOLY CROSS CHURCH IN BRZEG

#### Antonina ŻABA

**Abstract**. Researches of illusionary and architectural paintings carried out by the author, showed that in none of sacral interiors in Poland a characteristic mark of observer's stand called punto stabile has been preserved. In the article punto stabile restitution carried out on the basis of archival photography has been described.

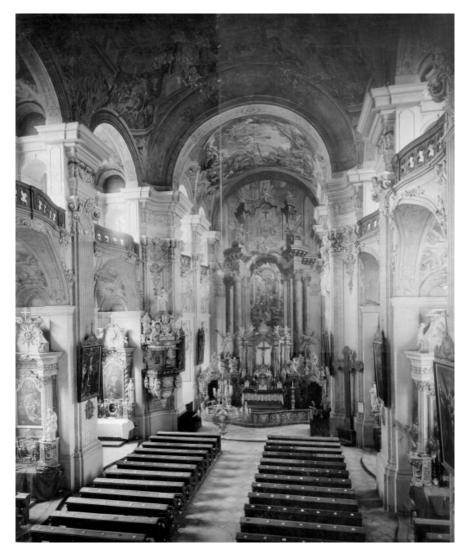
Fig. 1: The view on the nave floor in Raising of the Holy Cross Church in Brzeg, around the year 1906

During the researches on the quadratures carried out in sacral objects in Poland, the author did not find *punto stabile*. In many cases, church floors were exchanged, whereas in the places where original floors were found, there were no characteristic points. In the Household Equipment Museum in Ziebice, pictures presenting punto stabile were found. They are from the extensive pictures collection of a well-known Silesian artist, painter, works of art conservator, collector and traveller, Joseph Langer (1856-1918). As the conservator, Langer dealt with, e.g. baroque mural paintings in Silesia. One of the objects which the artist preserved was Raising of the Holy Cross Church in Brzeg. In two pictures taken during the church preservation, elements of nave floor with central placed 'star' were registered. For the restitution of its shape and size a picture made from the eastern empora was chosen (Fig.1 and 2). Picture of 37.4 x 45.4 cm size was stuck on the cardboard of 38.3 x 50 cm size. On the avers an address was given 'Atelier parterre' Ed. Van Delden – Hof-photograph from Breslau, where the picture was made. On the reverse there is information that the picture concerns 'Pharkirche Brieg' (presently Raising of the Holy Cross Church in Brzeg) and inventory numbers Mz-41-23/3 (No. 19.LIV and G VII 3/15) and MZ-47-32/2 (No. 18 LIV). Adam Organisty [4] proved that the picture was taken in 1906.

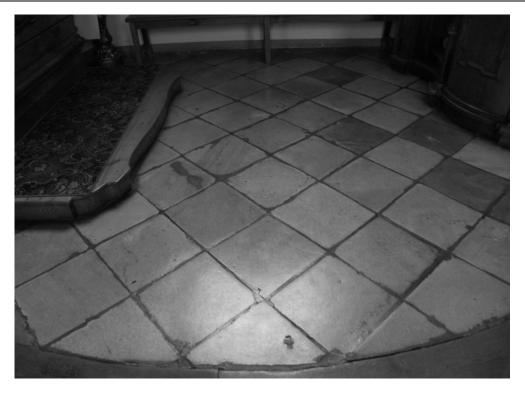
Fig. 6: The floor in the chapel from re-fitted III tiles

Next, a trial of verification of received tile sizes during the restitution was made. For such a purpose, the tiles in the church underwent an inspection. It was established that in two side-chapels, square tiles III were re-fitted (Tab. 1, position 9-10), of sizes closed to the restitutions II ones (Tab. 1, position 7-8). Tiles III were made from the same material as other fragments of original floors in Brzeg church. Probably, they were fitted in the nave before. Therefore, on the basis of tiles III sizes, the size of  $O_1$  and  $O_2$  circles diameters were measured (Tab. 1, position 11-12).

The discrepancy in the tiles sizes received as a result of I and II restitutions may come from the earlier mentioned picture features and not too precise placement of the tiles due to slight differences in their sizes (Fig. 6).
